LAKE JO-ANN DAM

NDI No. PA 00504  
PennDER No. 63-60

PHASE I INSPECTION REPORT  
NATIONAL DAM INSPECTION PROGRAM

Lake Jo-Ann Dam, Washington County, Pennsylvania  
NDI No. PA 00504, PennDER No. 63-60  
Inspected 28 March 1980

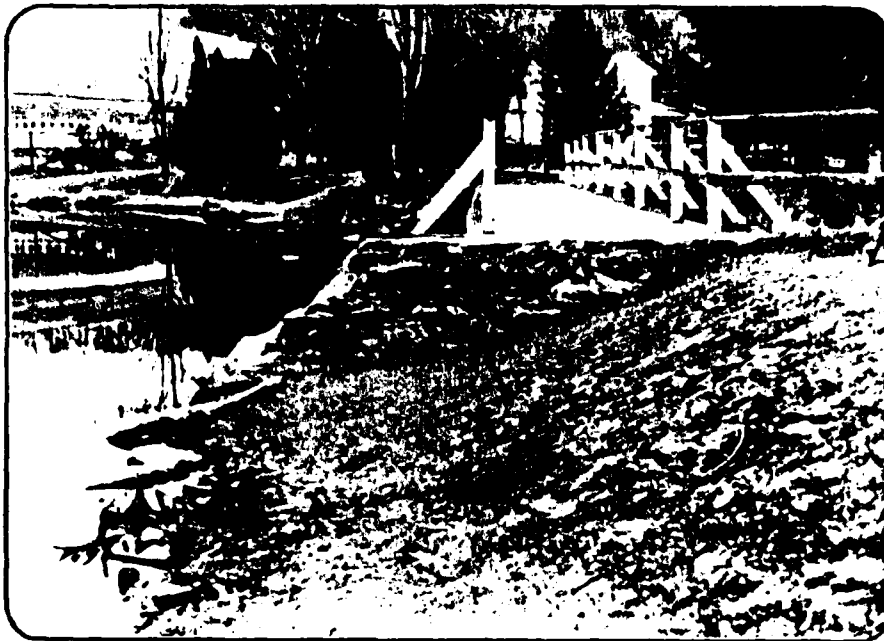
**View of the Upstream Face of the Embankment Looking from the Center of the Dam to the Left Abutment**

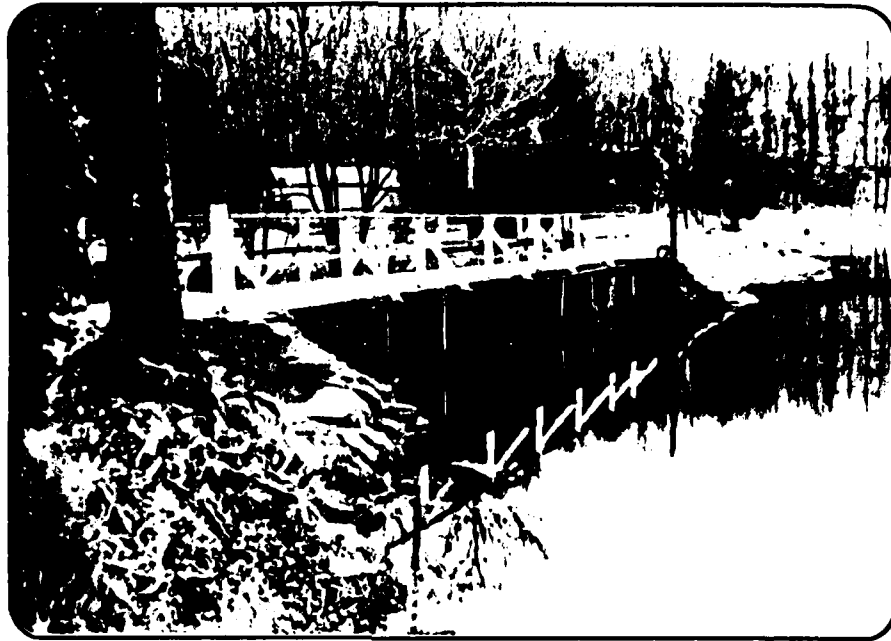
**PHOTO 3. View of the Upstream Side of the Spillway**

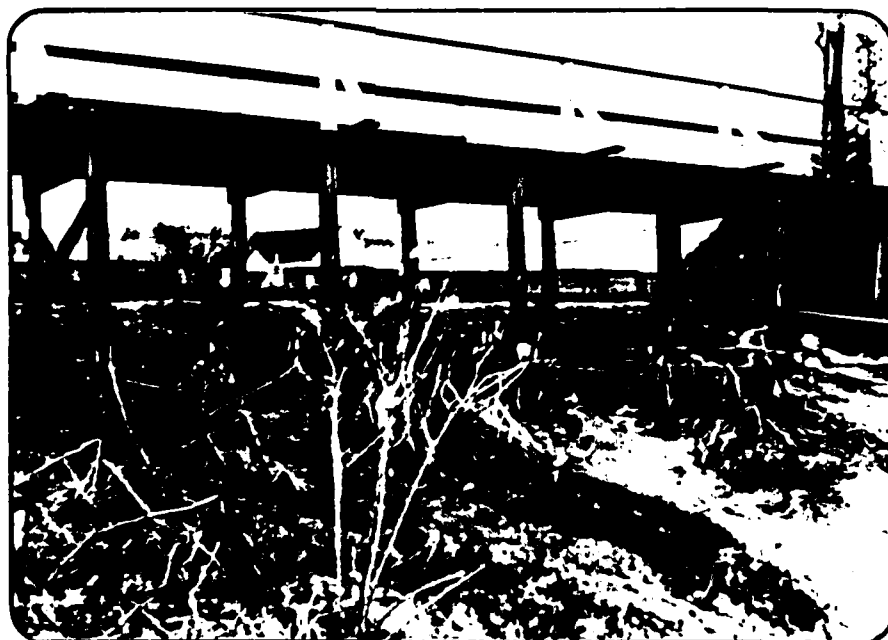
**PHOTO 4. View of the Spillway Looking Upstream**

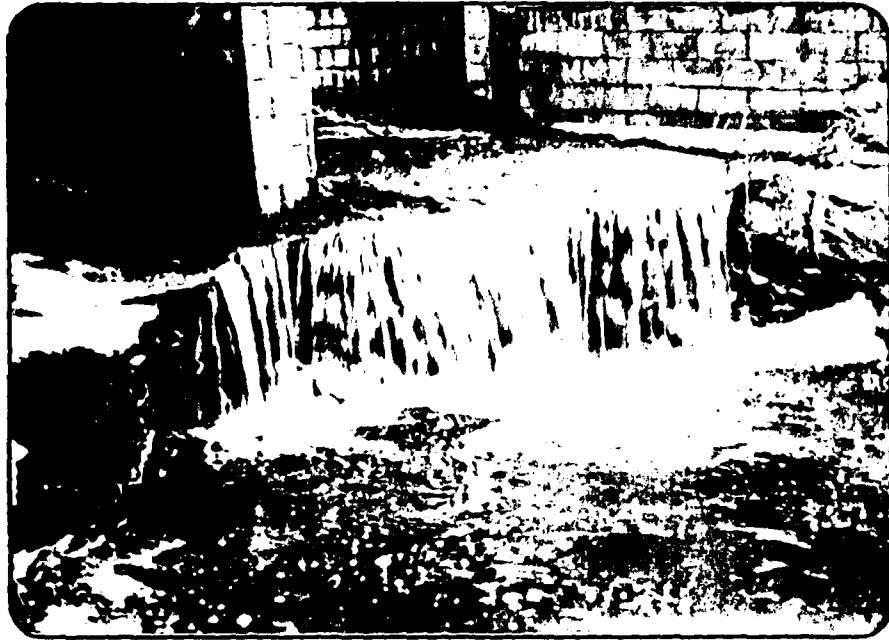
**PHOTO 7. Undermining of the Downstream End of the Spillway  
Discharge Channel**

- 6) Repair the spalled areas on the spillway weir.
- 7) The spillway discharge channel should be cleared of debris and vegetation and repaired. The undermined area at the downstream end of the channel should be filled and repaired.
